DEPARTMENT OF TRANSPORTATION

Quality Assurance and Source Inspection

Contract #: 04-0120F4Cty: SF/ALA Rte: 80 PM: 13.2/13.9File #: 1.28**WELDING INSPECTION REPORT****Resident Engineer:** Casey, William**Address:** 333 Burma Road**City:** Oakland, CA 94607**Report No:** WIR-027396**Date Inspected:** 02-Apr-2012**Project Name:** SAS Superstructure**OSM Arrival Time:** 1700**Prime Contractor:** American Bridge/Fluor Enterprises, a JV**OSM Departure Time:** 1730**Contractor:** American Bridge/Fluor Enterprises, a JV**Location:** job site**CWI Name:** See below**CWI Present:** Yes No**Inspected CWI report:** Yes No N/A**Rod Oven in Use:** Yes No N/A**Electrode to specification:** Yes No N/A**Weld Procedures Followed:** Yes No N/A**Qualified Welders:** Yes No N/A**Verified Joint Fit-up:** Yes No N/A**Approved Drawings:** Yes No N/A**Approved WPS:** Yes No N/A**Delayed / Cancelled:** Yes No N/A**Bridge No:** 34-0006**Component:** Tower**Summary of Items Observed:**

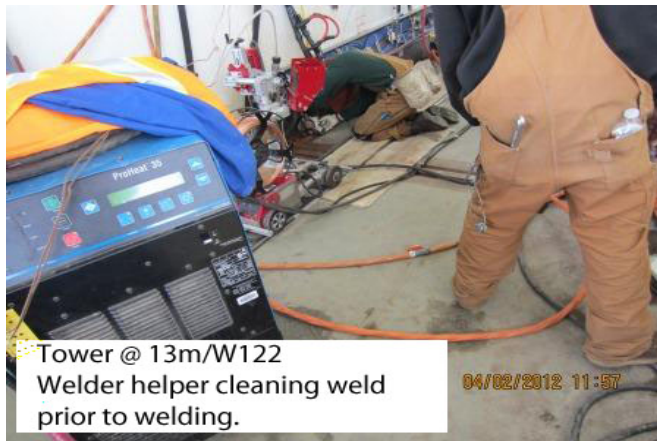
Later in the shift at Tower Base 13 meters diaphragm, weld joint number W122, QA randomly observed ABF certified welder Dan Ieraci welder ID#3232 continuing to perform 1G (flat position) Submerged Arc Welding (SAW) on the Partial Joint Penetration (PJP) T- joint between the 45mm thick external center diaphragm and 70mm tower. The welder was utilizing F7A6-EM12K-H8, 3.2mm electrode with corresponding Esab OK Flux 10.62 flux and implementing Caltrans approved Welding Procedure Specification (WPS) ABF-WPS-D15-4062-1. The joint being welded has a 45 degree bevel groove T- joint with an average root opening of 4.2mm and C-channel installed underneath that will serve as the backing bar. The plates were preheated to more than 225 °F. ABF/QC Fred Von Hoff was noted monitoring the welding parameters of the welder with measured working current of 550 amperes, 32.5 volts.

The QA Inspector noted the welding not completed at this location on this date.
